Collision repair estimate

Right front damage on a 2022 compact SUV, for insurance claim KM-26-448172.

ESTIMATE # BWC-E-26-1906
ISSUED Dec 2, 2026
VALID UNTIL Jan 2, 2027

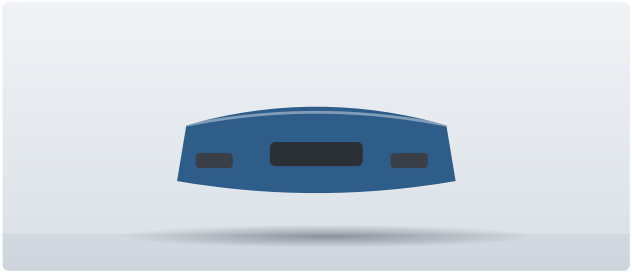
Bumper cover

Primed by the factory, painted by us to match your car's color code.

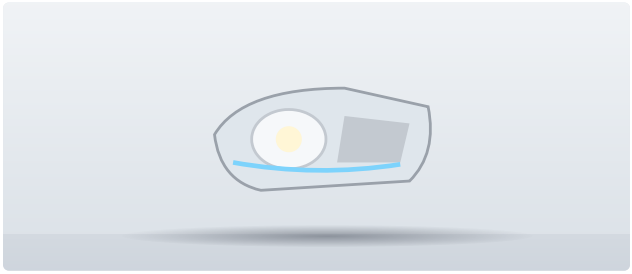
LED headlamp

The complete assembly, aimed after fitting.

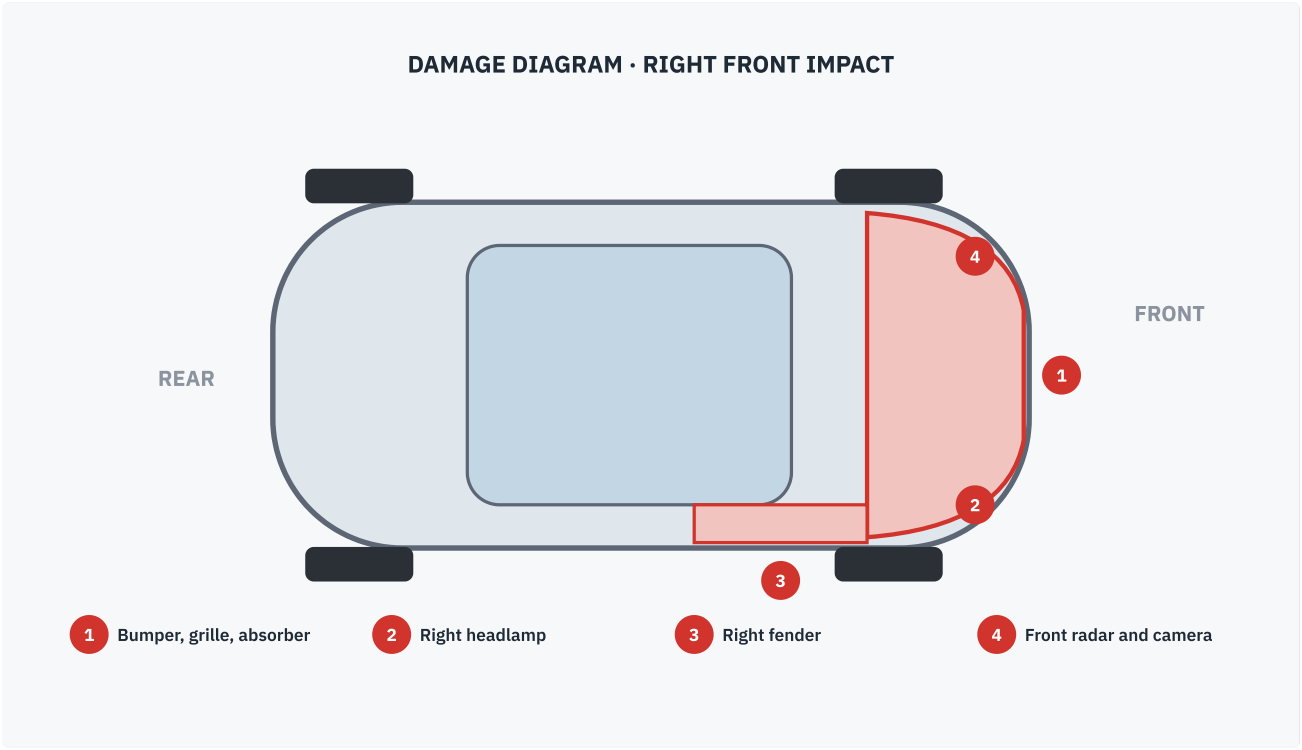
Damage found

The impact pushed in the bumper and grille, broke the right headlamp and creased the fender. The structure measured within factory tolerance, so no frame straightening is needed.

#	PART	DAMAGE	REPAIR
1	Bumper, grille, absorber	Cracked cover, absorber crushed	Replace
2	Right headlamp	Lens and mounting tabs broken	Replace
3	Right fender	Crease along the wheel arch	Replace and refinish
4	Front radar and camera	Moved with the grille	Calibrate
—	Right front door	No damage	Blend paint only
